Solar Array Mast Imagery Discussion for ISIW

NASA Johnson Space Center
Astromaterials Research and Exploration Science (ARES)
Image Science and Analysis Group (ISAG)
Gary Kilgo / Barrios Technology / Jacobs JETS Contract / XI4
January 2017

SAW Mast Inspection Back Ground

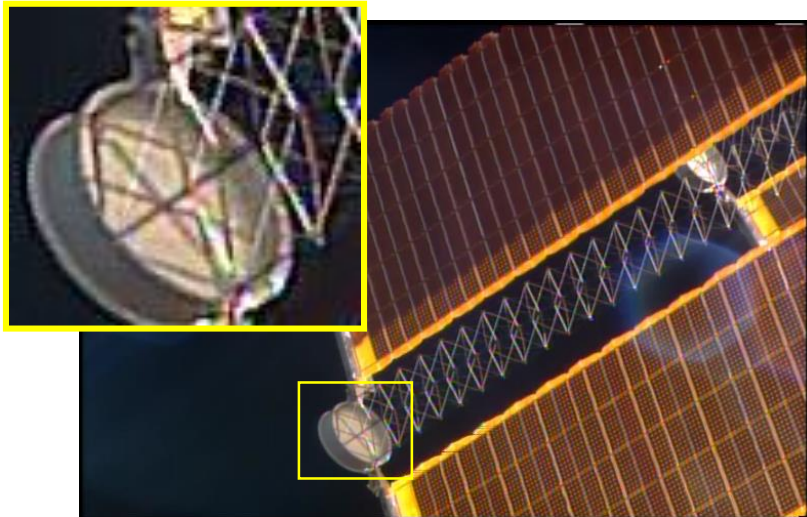
CP3 View of S4 Array

- **Results:**
 - **No mast damage was evident from review of the S4 and P4 survey video, however the review is considered incomplete due to low video resolution..**
 - **Damage detection is limited to “severe” MMOD damage evident by a longeron or batten being completely separated and out of normal orientation with multiple surveys.**
 - **It is the conclusion of the Image Science and Analysis Group that ETVCG video is not adequate to accomplish a risk mitigation survey.**

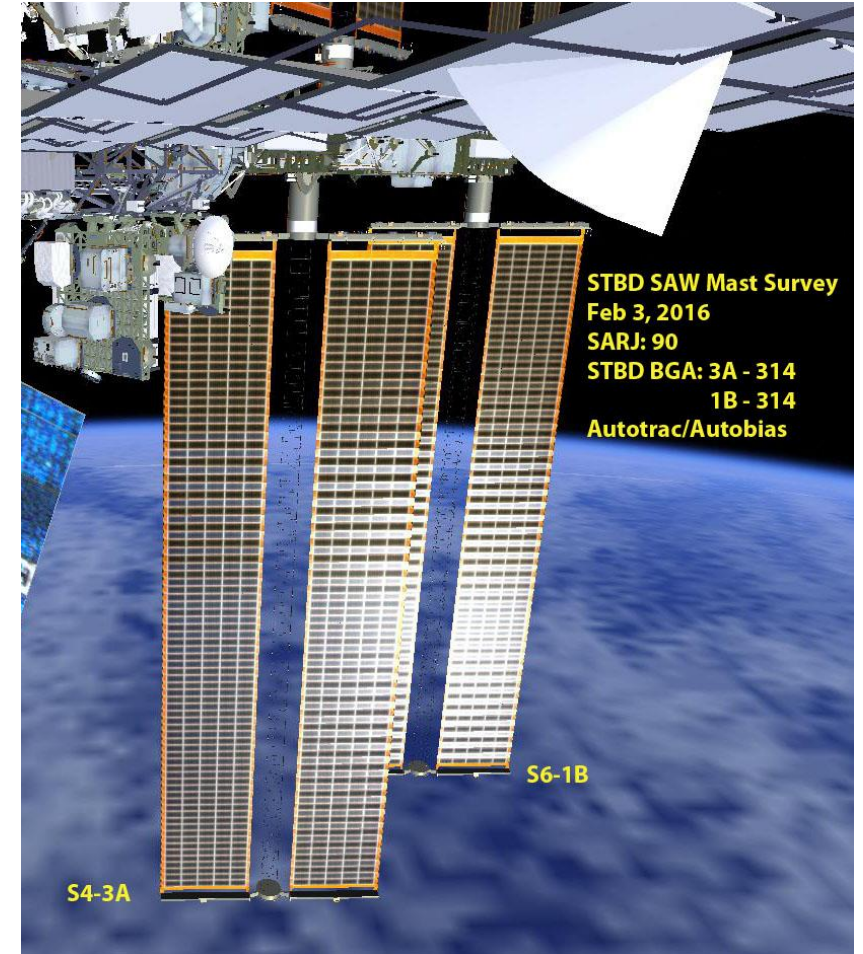
This survey was the first attempt to have the crew take the images while the array's were in autotrack with an autobias?. The crew took the images a few minutes before the optimum time period. This resulted in a overlapping longerons on the inboard (3A mast).

Taking images while the SAW is in **autotrack** is possible, it is not the preferred method. If **autotracking** is used the crew must take the imagery at the designated time.

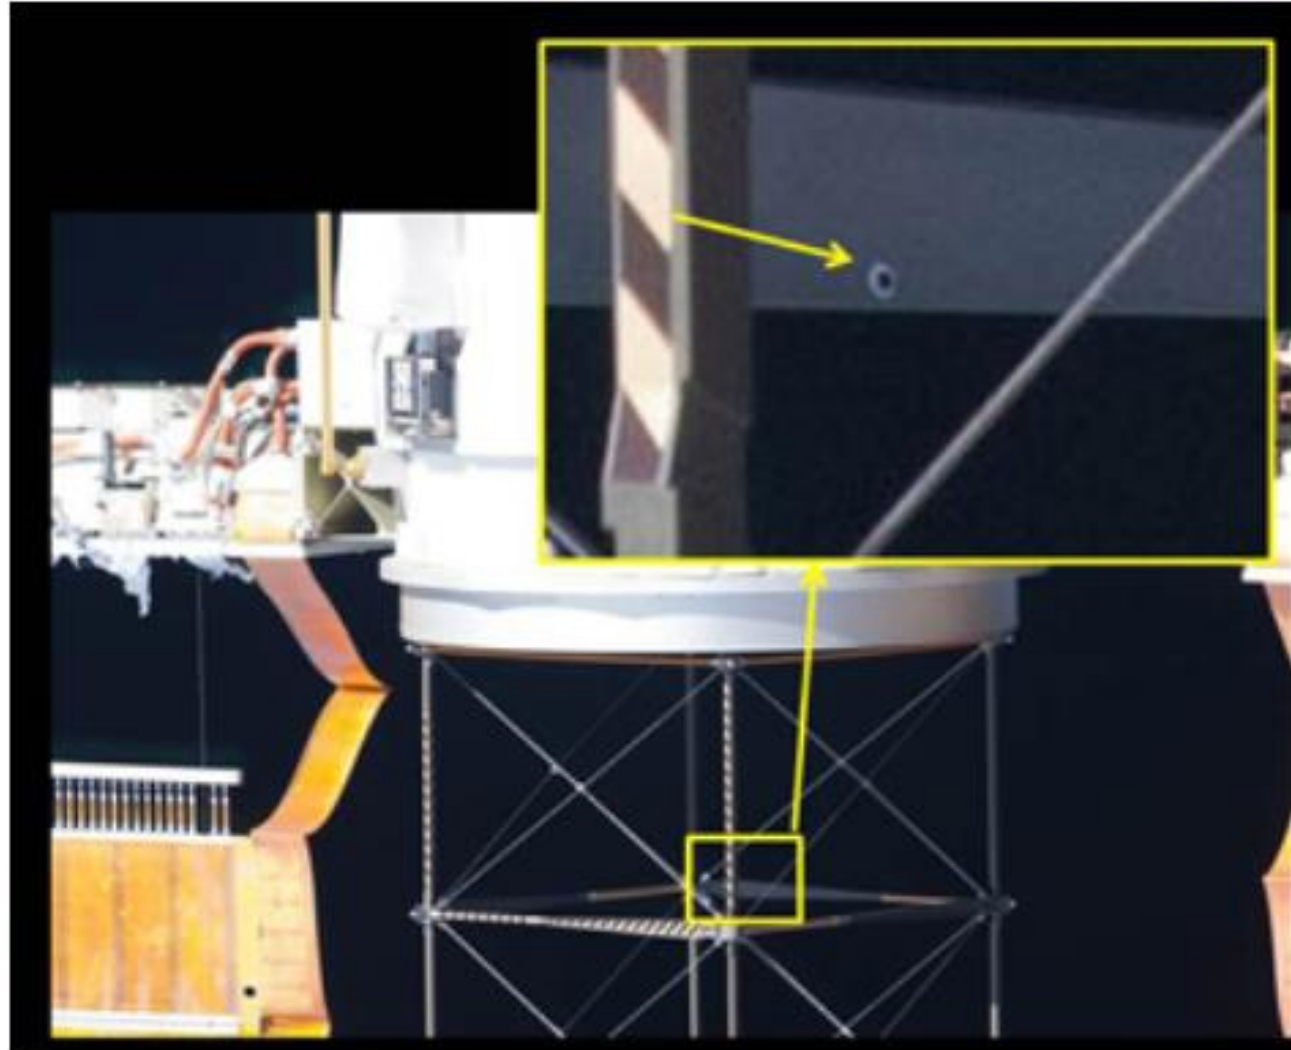
P4-4A SAW Mast Bay 0

- 1) MMOD strike on P4-4A Rigid Batten
- 2) MMOD strike on P4-2A Flex Batten (side 1)
- 3) MMOD strike on P4-2A Flex Batten (side 2)
- 4) Area of Interest on Bay 4 Longeron and Rigid Batten.

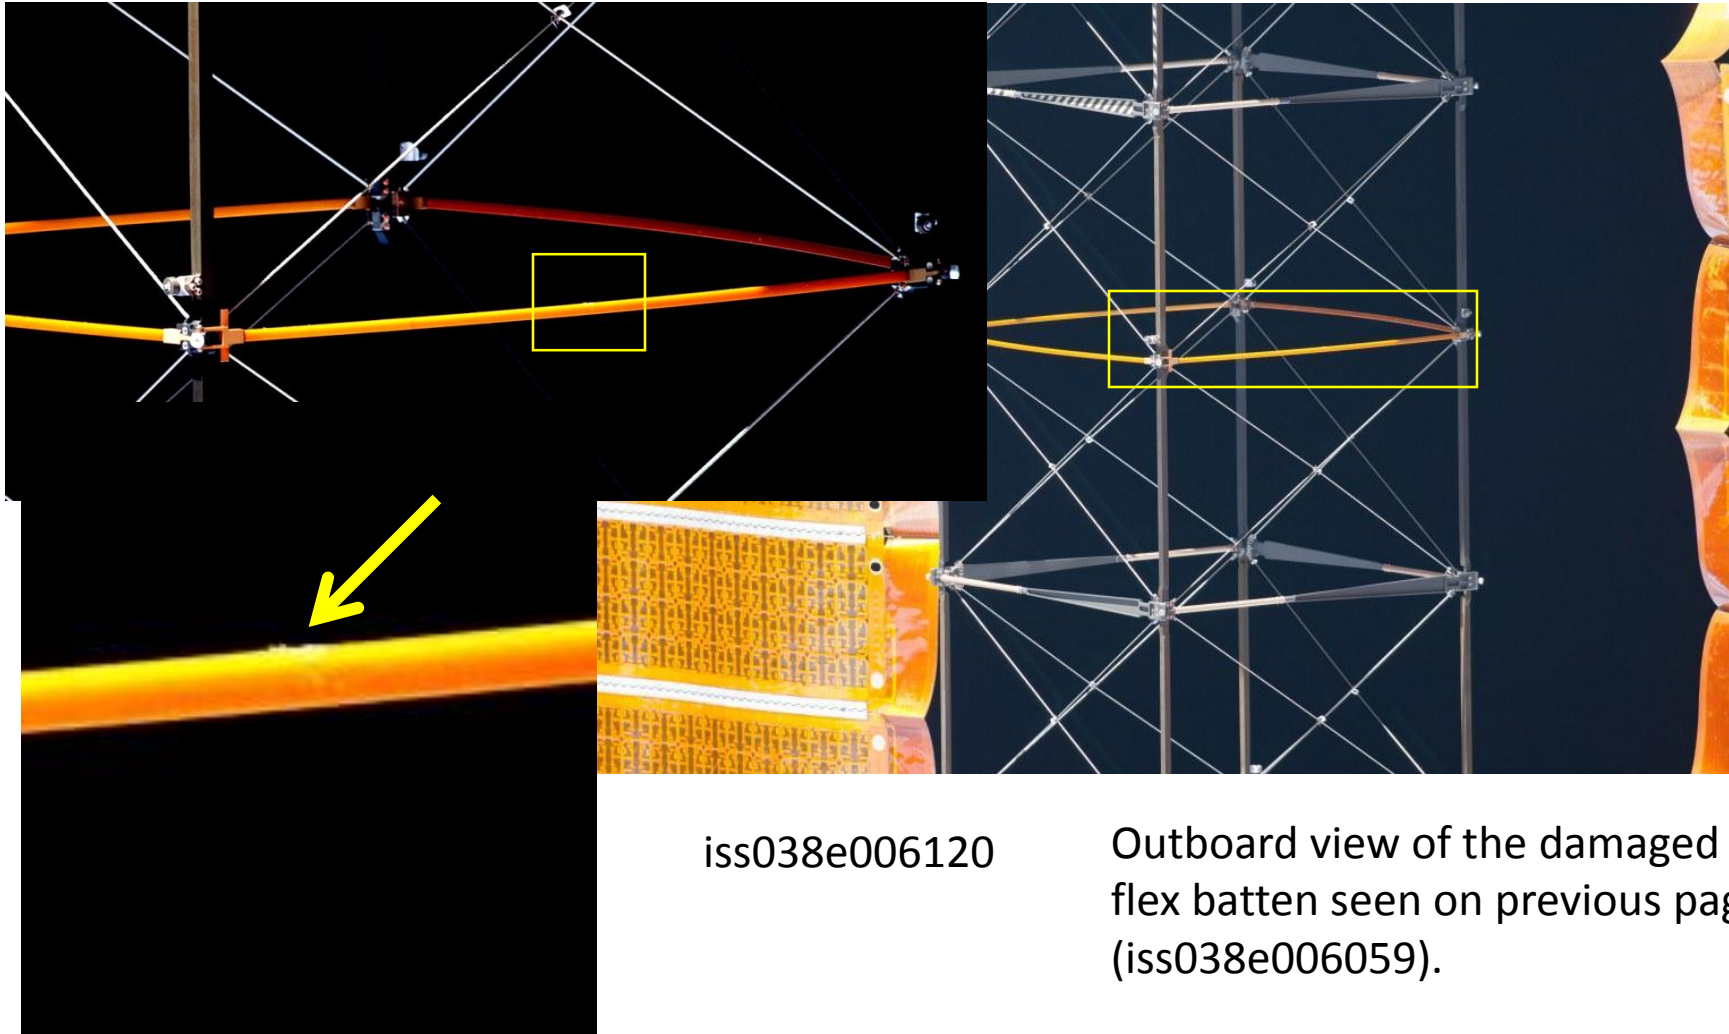
P4-2A SAW Mast Bay 1 (array in nadir position)

Outboard view of the damaged
flex batten seen on previous page
(iss038e006059).

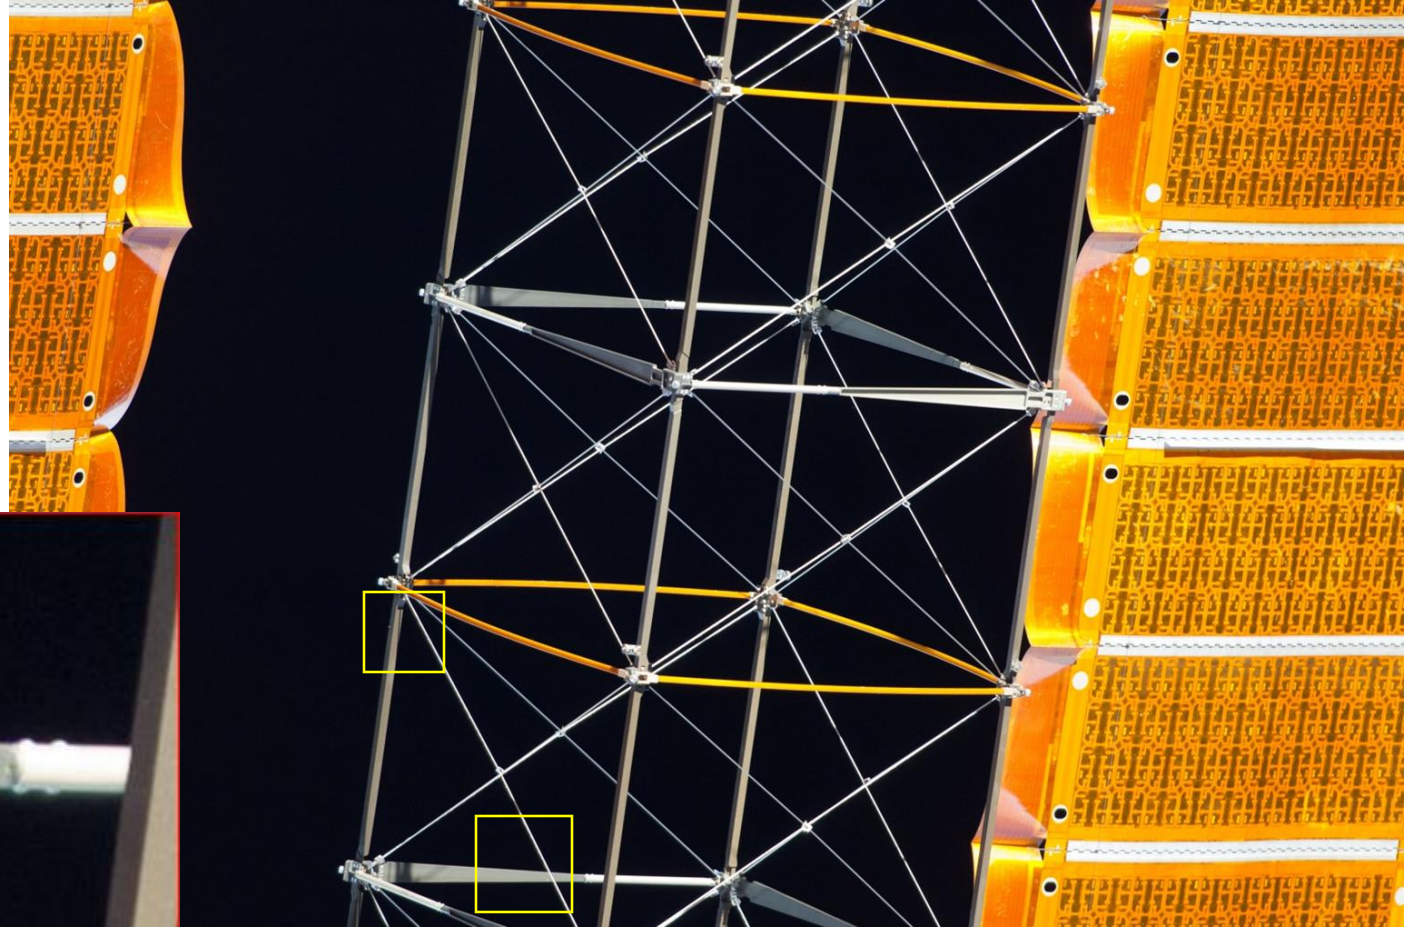
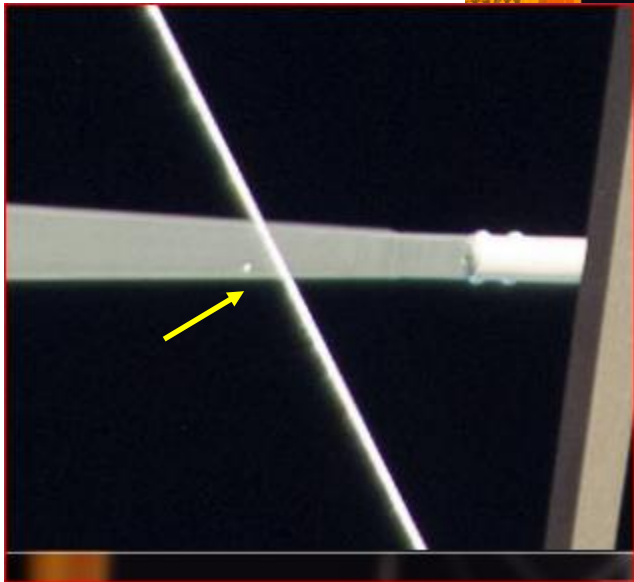
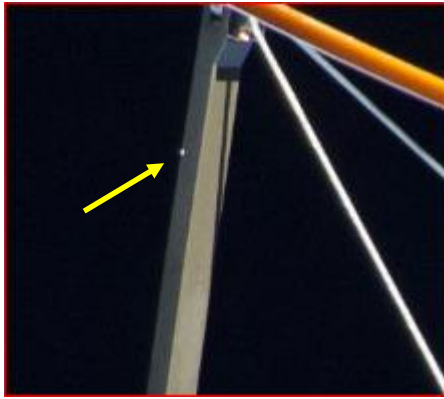
S4-3A - Bay 3, 4

AOI on Bay 4 Longeron and Rigid Batten
